Over-pressurization during ground testing (30S)

Deformation and local failure SHELL CONTAINER ma lander spacecraft "TMA-04M» № 704

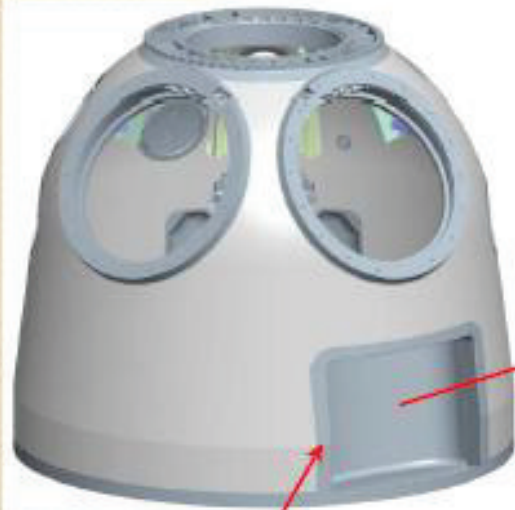
- **Soyuz 30S** - The Soyuz vehicle #704, slated for flight 30S (TMA-04M), had a problem during ground testing, prior to its shipment to Baikonur.
 - During pressure testing of the descent module and the pressurized section of the propulsion module, the vehicle was over pressurized and as a result it caused a leak in the area housing the hydrogen peroxide system for the thrusters that are used during descent and landing (*see next page*)

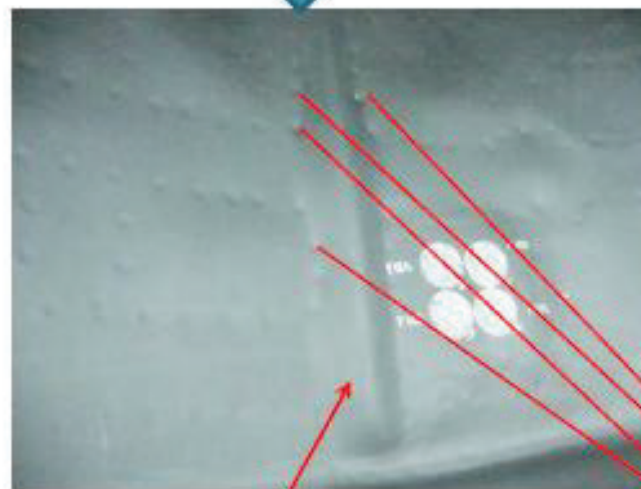
In the "Soyuz TMA-04M» № 704

Corrugations on the outside of the
container PGA

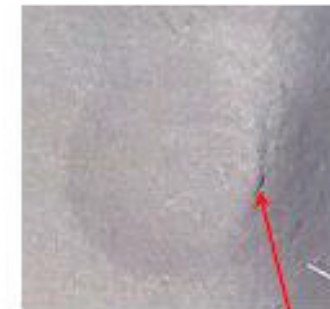
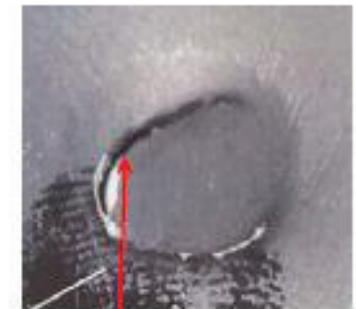
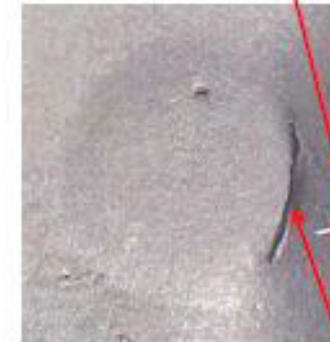
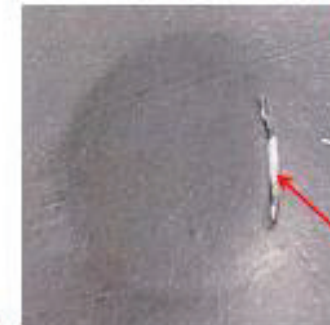
Cracks in the shell of the container on the
PGA points to the power set of welding
